Manhole Inspection Summary

Manhole # S37C__031MH

Insp Date: **10/20/08 12:01 PM**

Location Address: **cross from 330 e pleasant st**

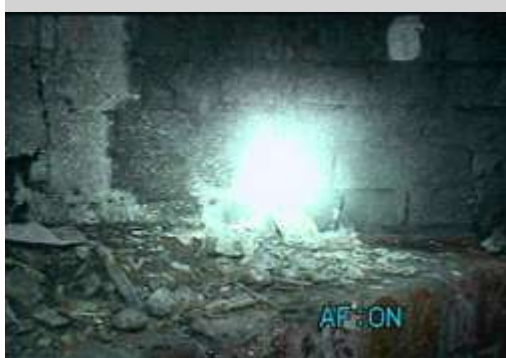
MISCELLANEOUS

bench debris

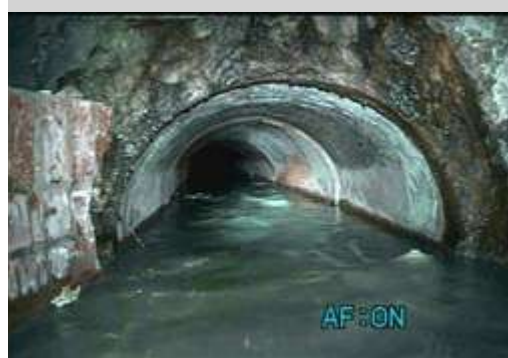
Defect 4

Infiltration: ☐ None ☐ Joint ☐ Cracks ☐ Mortar ☐ Roots ☒ **Wall**

Barrel Infiltration

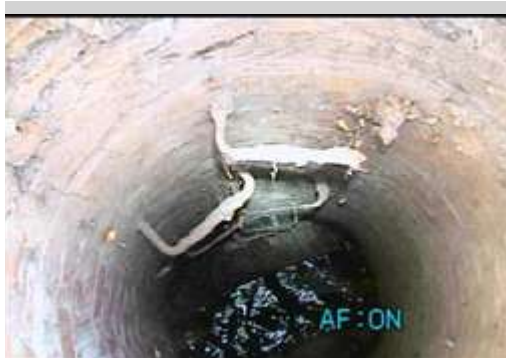
Defect 3

Steps Count: **7** Missing: **3** ☒ **Corroded**

corr steps

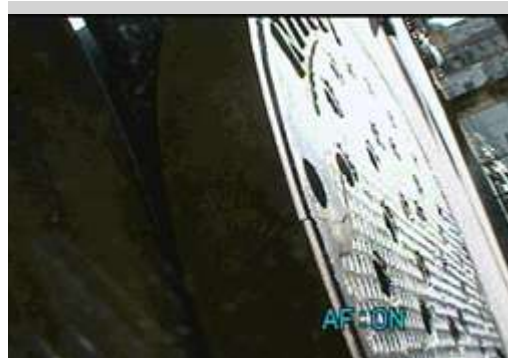
Defect 2

Type: **Sanitary** Condition: **Cracked** Cover Material: **Cast Iron**

cracked cover

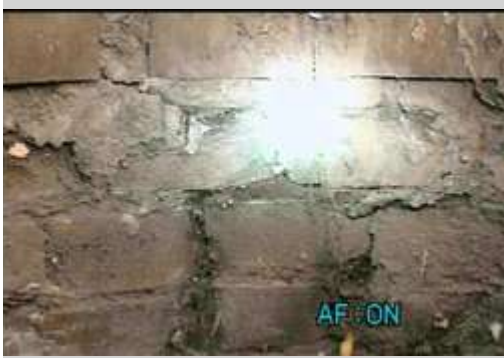
Defect 1

Condition: ☐ Sound ☒ **Cracked** ☐ Root Intrusion ☐ Loose Brick ☒ **Deteriorated**

cracked frame adj

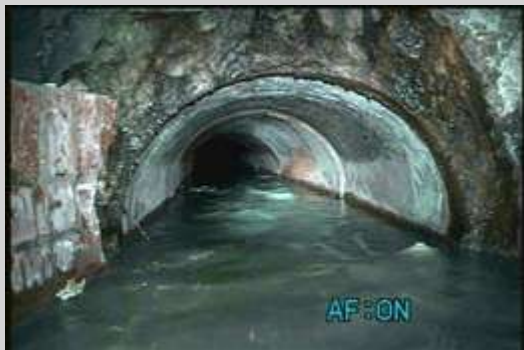
12 O'Clock Outflow

21 in. Circular Gravity Sewer
Pipe Out @ 12 O'Clock

Pipe Material: **Clay** ☐ Pipe Lined

Invert Depth: 12.10 (ft.) Flow Characteristics: **Slow**

Infiltration: **None** Pipe Seal Cond: **Unknown**

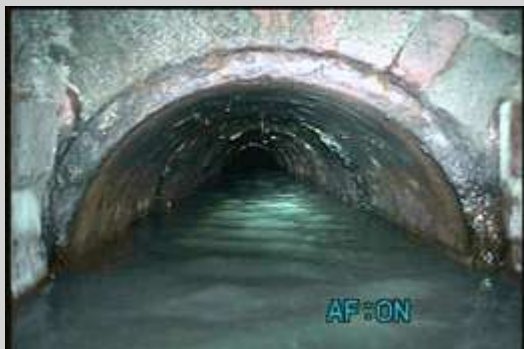
6 O'Clock Inflow

21 in. Circular Gravity Sewer
Pipe In @ 6 O'Clock

Pipe Material: **Clay** ☐ Pipe Lined

Invert Depth: 11.90 (ft.) Flow Characteristics: **Slow**

Infiltration: **None** Pipe Seal Cond: **Unknown**
